Deployment of Sensor Technologies and Supporting Systems for Enhancement of the Commercial Explorer™

[a series of robotic platforms for the Inspection
of Un-Piggable Transmission Pipelines]

26th World Gas Conference | 1-5 June 2015 | Paris, France

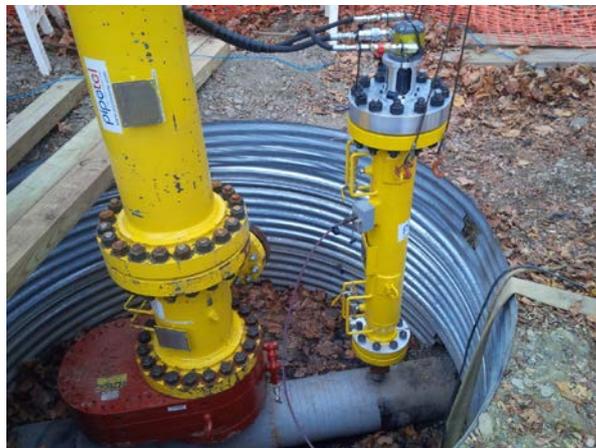
The in-line charging system consists of the insertion module and the power module. The insertion module is attached to the pipe and contains an actuator for connecting the charge plug to the robot. The insertion tool was designed to mount to a 2" hot tap fitting on any live pipeline from 6"-36" in diameter. Off-the-shelf components were explored for the various sub-systems but it was determined that the insertion tool and the battery charging device needed specific design for the use in the Explorer charging situation.

The power module supplies regulated power for charging to the insertion module. The power module can be implemented as a battery bank in a pressurized canister. The considerable weight of the batteries was factored into the layout and designed to be kept above ground during the installation and use of the in-line charging tool. The resulting

Figure 4: In-line Charging Tool in Live Setup

product can be seen in Figure 4.

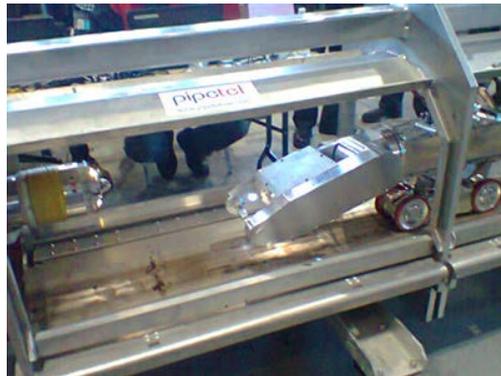
The rescue tool, first created for the Explorer 20/26 platform but also adapted for platforms as small as the Explorer 6/8, was designed to be deployed through a standard hot tap fitting like the one used to launch the Explorer robot. Once in the pipeline, the rescue tool is designed to connect with a disabled robot and to carry out basic diagnostics to determine the cause of failure to the system. The rescue tool has the capability built into it to restore power and communications to the robot in some cases and in others, to tow the disabled robot to a section of pipe that where the robot can be recovered, all under live conditions.

Figure 5: Rescue Tool approaching nose of EXP

The rescue tool has a configuration very similar to the Explorer platform; see Figure 5. Given its mission to potentially tow an Explorer robot, its mechanical components and electric motors are upgraded. The nose module at one end, the end to connect and grasp the incapacitated robot, is modified to include a mechanism that can grab the disabled robot and establish electrical and wireless connection with it. Diagnostics can be run to determine reason of failure of Explorer. Also, the batteries of the disabled Explorer can be recharged using the battery power stored on the rescue tool. Finally, the rescue tool can communicate with the various subsystems of Explorer and transmit wirelessly information and commands to and from the operator.
